Balancing of aeroderivative turbine

Abstract

GE's Machinery Diagnostic Services team was invited to investigate vibration issue on an aero derivative gas turbine installed on a power plant. Machine train consist of a generator and aero derivative turbine. The unit was under commissioning and it wasn't possible to have it at nominal speed for a long time because of high vibration on Power Turbine bearings. Vibration testing was carried out using ADRE 408 DSPi (Dynamic Signal Processing Instrument) to hook up vibration data from the existing Bently Nevada's 3500 Series vibration monitor system. Relative vibration data were collected from the Bently Nevada's Rack 3500 monitor buffered outputs. Each of the Machine Train's bearings is monitored by Bently Nevada XY proximity probe pair. Absolute velocity transducer were also installed on generator bearings and bearing #4. The shaft rotates counter clockwise, when viewed from the driver (Gas Turbine) to the driven. The first fire of this Unit was carried out the 25 May 2010. The unit had many probes in alarm. The generator DE was running in alarm and after a period of running at idle began to creep from 86um pp to 96um pp, the unit was

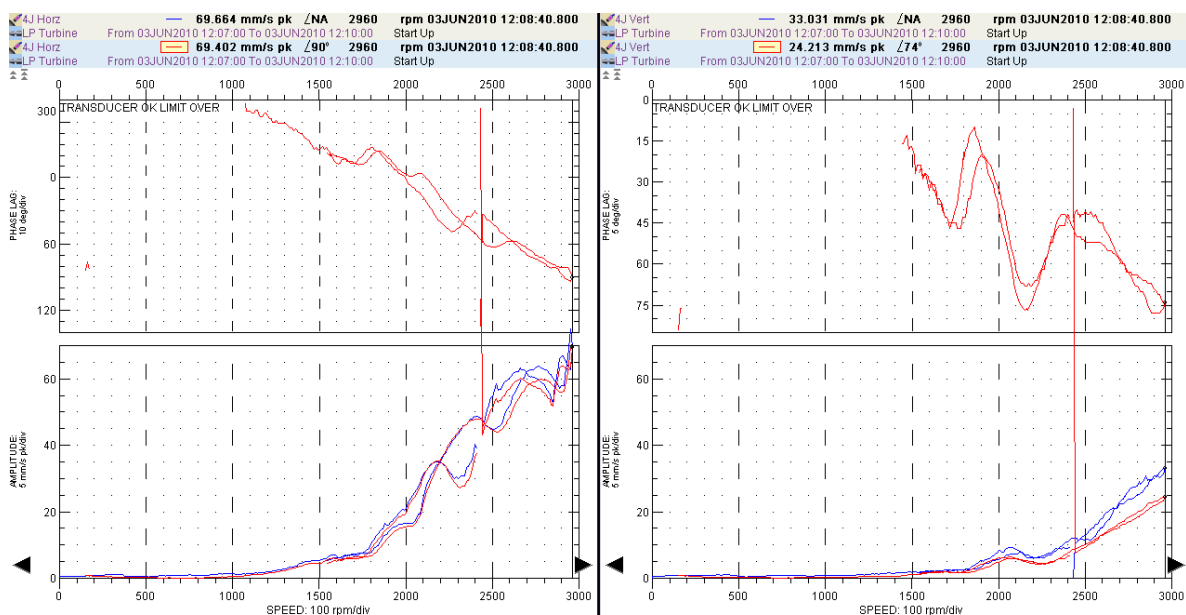
Figure 2: Bode plot, direct and 1X for velocity probes 4JH and 4JV (bearing 4)

The commissioning team checked twice the coupling mounting and the alignment but proven ineffective. The DCS trends showed only overall vibration trends so diagnostic system was needed to obtain more informative characteristics. A first set of vibration data was recorded using ADRE 408 DSPi (Dynamic Signal Processing Instrument) connected to vibration signals from the existing Bently Nevada's 3500 Series vibration monitor system. During the start up the vibration level exceeded the vibration limits. For bearings #3 and #4 the alarm level was 160 $\mu\text{m pp}$ and the danger level was 230 $\mu\text{m pp}$. The shaft vibration for bearing #4 reached **385 $\mu\text{m pp}$** and the casing vibration was **70 mm/s pk** (Fig.2 & Fig.3) at 2900rpm. The vibration was well above the limits

The high level of seismic probes indicated that an important amount of the energy of the rotor displacement was transferred to the casing. From Bode plot (Fig.2), it could be noticed that 1X was the main component of the vibration signal and 1X was increasing with the speed. The behaviour of the machine looked to be the same during start up and shutdown which means that the behaviour of this phenomenon was repeatable

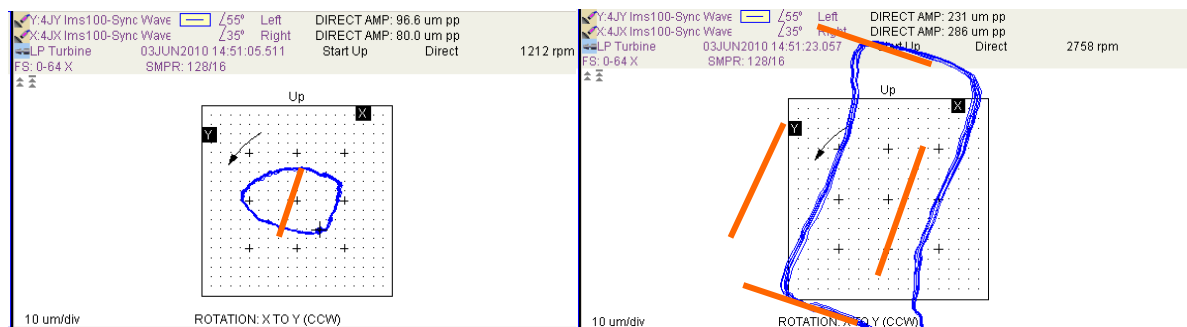
Figure 4: Direct orbit for bearing 4 showing rub condition

Moreover, the orbit shapes (Fig.4) was showing several flat portions from 1200rpm to 3000rpm which could be associated to rub condition. It is always difficult to know if the rub is the cause of the high vibration or if the rub is the consequence

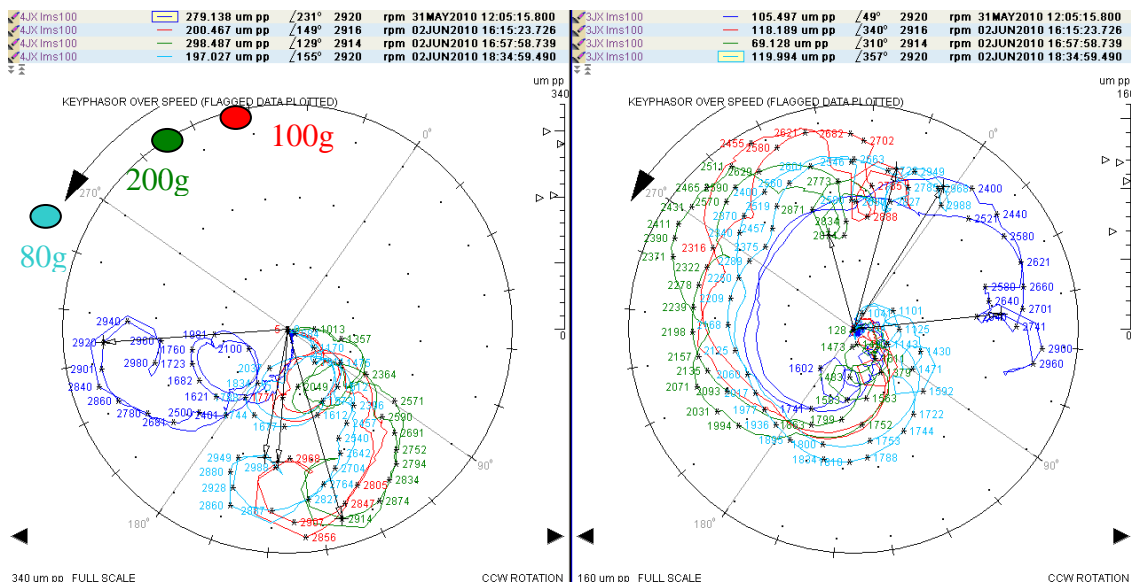
Figure 6: Polar plot for probes 4X and 3X. Several runs

- Initial run (Blue) was recorded by generator OEM team.
- 1st Run (Red): A trial weight of 100g was added at 0° from the Generator Kph. This weight had an insignificant effect on the vibration amplitude but it changed the angle by 90°
- 2nd Run (Green) a trial weight of 200g was added at 20°CCW from the Generator Kph. The 100g at 0° was not removed. The weight had an insignificant effect on the vibration amplitude and on the vibration angle.
- 3rd Run (Blue) 200g and 100g weights were removed. 80g at 50° CCW was added. This modification had no effect on the unbalance.

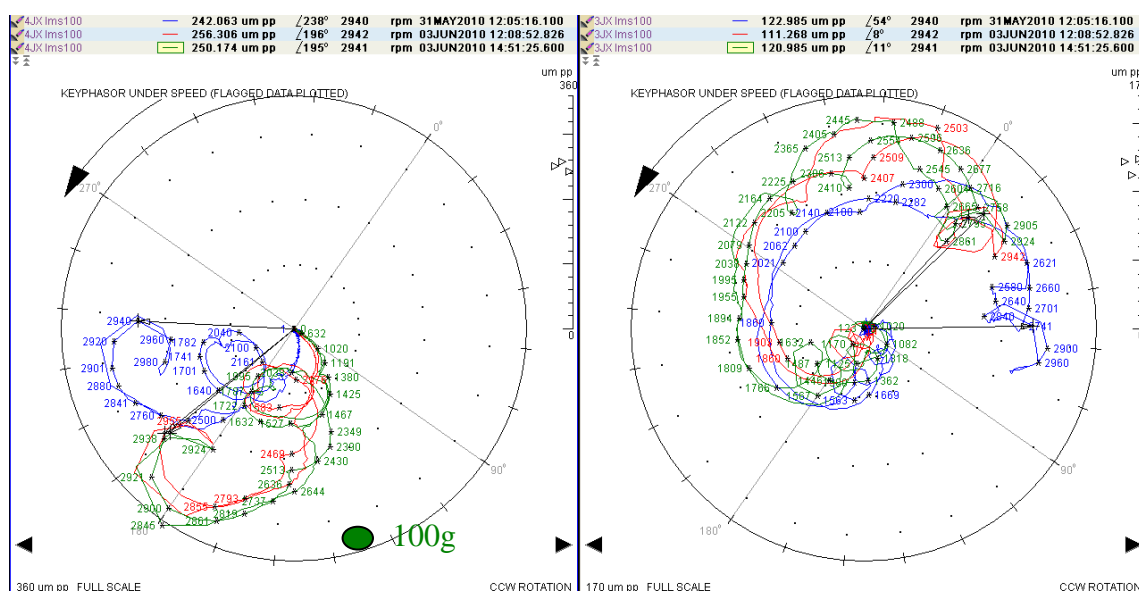
Figure 7: Polar plot for probes 4X and 3X. Three runs

- Initial run (Blue) was recorded by generator OEM team.
- 4th Run (Red): all the weights were removed, so the machine was in the same condition than the 31st of May run. The angle was shifted by 90°. The machine had not the same behaviour in the same condition. It was concluded that behaviour was nonlinear and something moved or changed between the 1st run and the 4th run.
- 5th Run (Green) A trial weight of 100g was added at 220°CCW from the Generator Kph. The weight had again NO effect on the vibration amplitude and on the vibration angle.

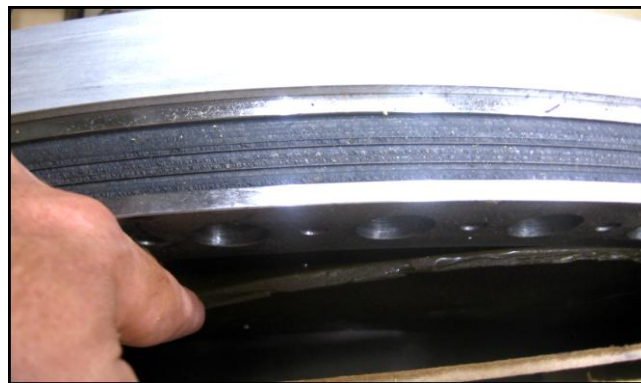
Figure 8: Picture of the wax which was found in the coupling

From field and factory experience it was decided to disassembly the coupling between the generator and the turbine to check if the shipping protection wax was removed before the start of the unit. At each end of the coupling, one kilogram of wax was found. For this unit, the typical mass, which is used to balance it, is 20g. This wax (Fig.8) was the cause of the high vibration level and it was a very important unbalance (around 1kg / 2kg)

After removing the transportation wax the last run was done to verify the level of vibration. The machine was able to reach full speed with a low level of vibration (Fig.9)
