# Compressor rub verified by rotating phase symptoms

Nicolas Péton, Charles Grislin<sup>1</sup> and Guillaume Christin<sup>2</sup>

<sup>1</sup>GE Measurement and Control, 14 rue de la Haltinière, 44303 Nantes, France

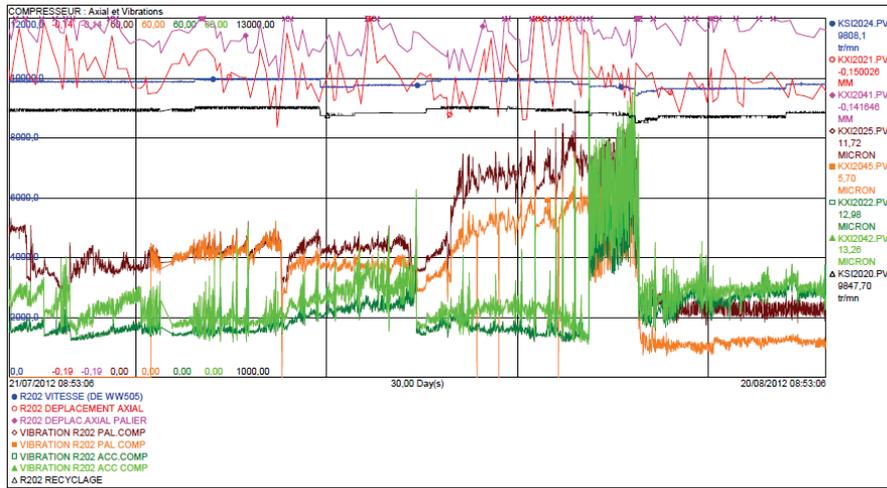
Based on the observed increasing vibration trend at the compressor bearings (Figure 2), the plant management suspected a problem with the machine. They requested a GE Measurement and Control Machinery Diagnostic Services (MDS) Engineer to come to the site to collect data (with ADRE 408) to identify the cause of the increasing vibration

Figure 2: Control System 30 day data trend showing an unusual period of vibration increase at the compressor bearings (green traces)

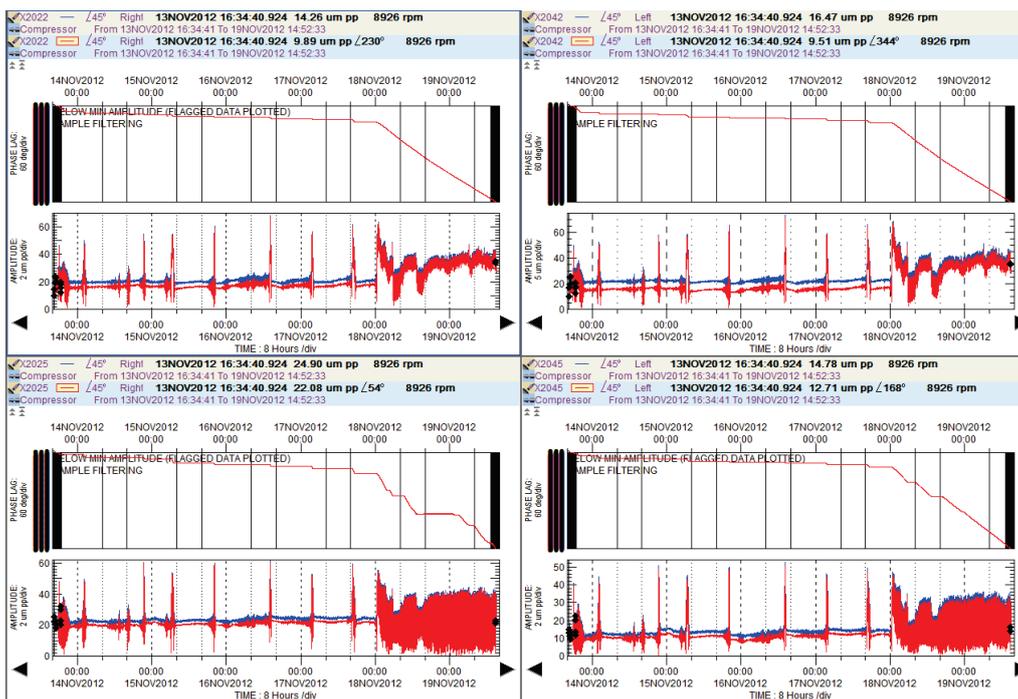
The MDS engineer recorded a few hours of vibration data with ADRE while the compressor was operating in steady-state conditions. During this time, a few new brief high vibration events were observed (Figure 3). The diagnostic engineer analyzed the vibration and confirmed that it was related to 1X (rotating speed frequency) shaft vibration changes at the compressor bearings.

Figure 3: ADRE trend plots showing shaft relative vibration trends at the compressor bearings. These particular vibration events did not cause a trip

An increase in the 1X vibration component implies that either the centrifugal force increased for the time of event or the dynamic stiffness was reduced, or that both happened at the same time. Examples of situations leading to such effects can be changes in unbalance conditions, changes in alignment or other preload forces. Each of these effects can have several different causes

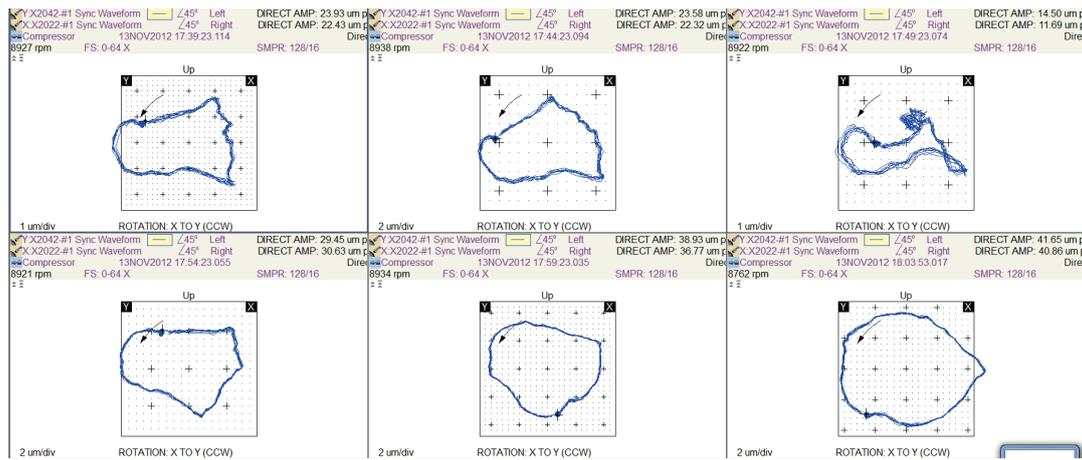
Figure 4: Sequence of direct waveform orbit plots showing changes over the time of monitoring

Vector ompensation was not possible in this case, as no shutdown data was available for reference. However, if the electrical and mechanical runout signal had stayed constant during this period (as it normally does) the direct orbit shape shouldn't change unless there is an ACTUAL change in the precession of the rotor centerline. Such changes in orbit shape can be caused by internal rubs between rotating and stationary components

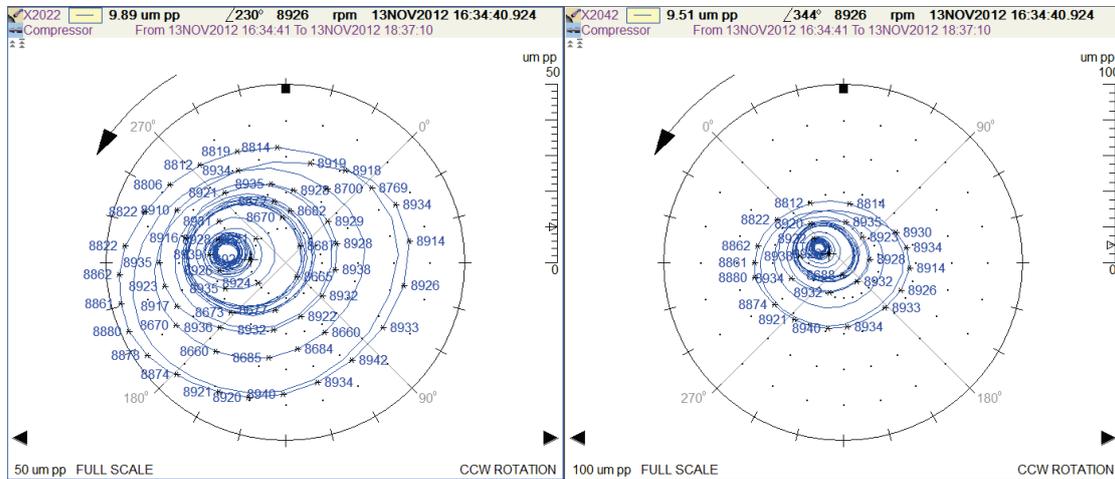
Additionally, the MDS engineer reviewed polar plots, which show the synchronous-filtered (1X) amplitude and phase for the vibration measured at the compressor bearings (Figure 5). These plots indicated an interesting situation of constantly-changing phase, which is a classic symptom of a light rub in rotating machines

Figure 5: These 1X polar plots show continuous changes in amplitude and phase of the vibration measured at the compressor bearings.

By correlating the observed symptoms described above, the diagnostic engineer was able to identify the presence of light rub conditions leading to shaft bowing and resulting in 1X vibration increase with constantly changing phase angle (Reference [1])

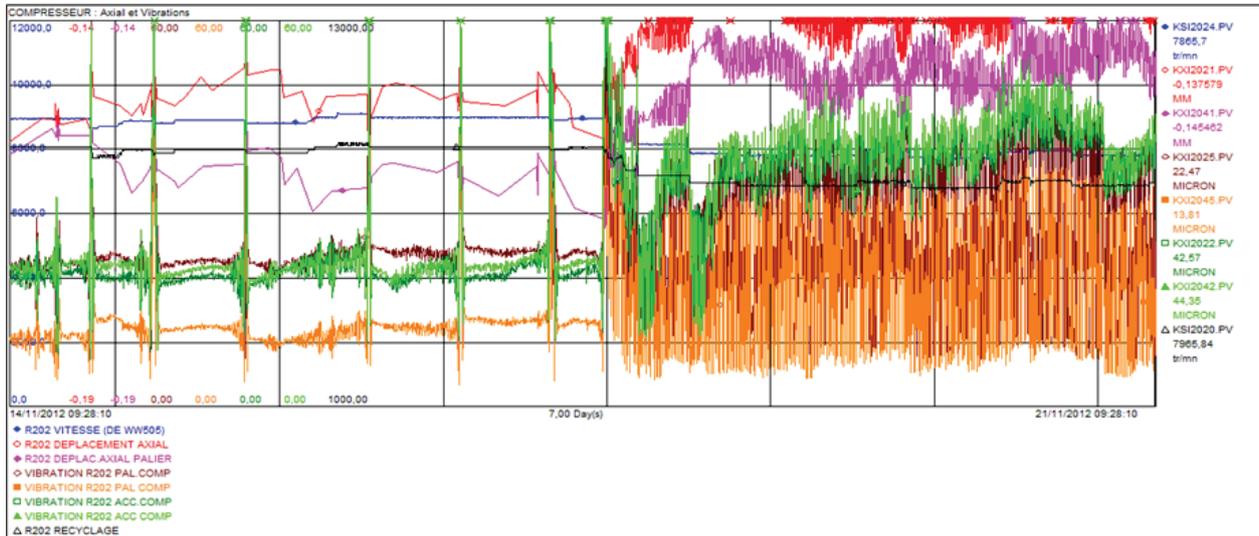
A week-long trend of control system data is shown in Figure 7. This plot shows an increase in the frequency of occurrence of the high vibration events. The phenomenon, which began as being infrequent, became more and more frequent as time went by. The customer observed that only by changing compressor speed were they able to reduce the vibration levels

Figure 7: Data trend from 14 through 21 November, shows that the high vibration event began occurring more frequently.

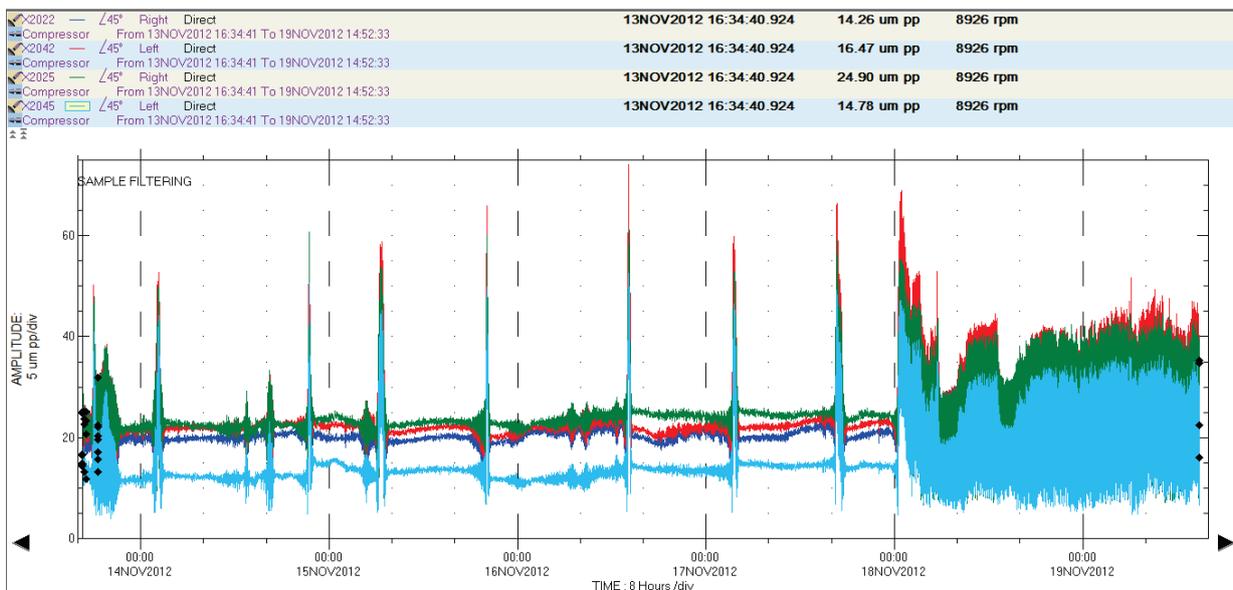
He hypothesized that a possible explanation for this behavior was the continuous formation of deposits in the compressor seals. Once the deposits exceeded the available clearance, a light rub would be developed at one point of the shaft surface, causing an increase of the shaft surface temperature and subsequent shaft bowing. The shaft bow, and increased vibration would then clear the deposits, restoring seal clearance and reducing vibration levels until the next time deposits built up to a significant level

Since the high vibration events were occurring with increasing regularity, (Figures 8 and 9), it was possible that more and more deposits were forming in the seals, and they were no longer being removed by periods of rubbing. Two areas were suspected for the deposits – the oil seals or the labyrinth seals

Figure 8: ADRE « direct » (unfiltered) vibration trend for a 6 day period from 13 through 19 November.

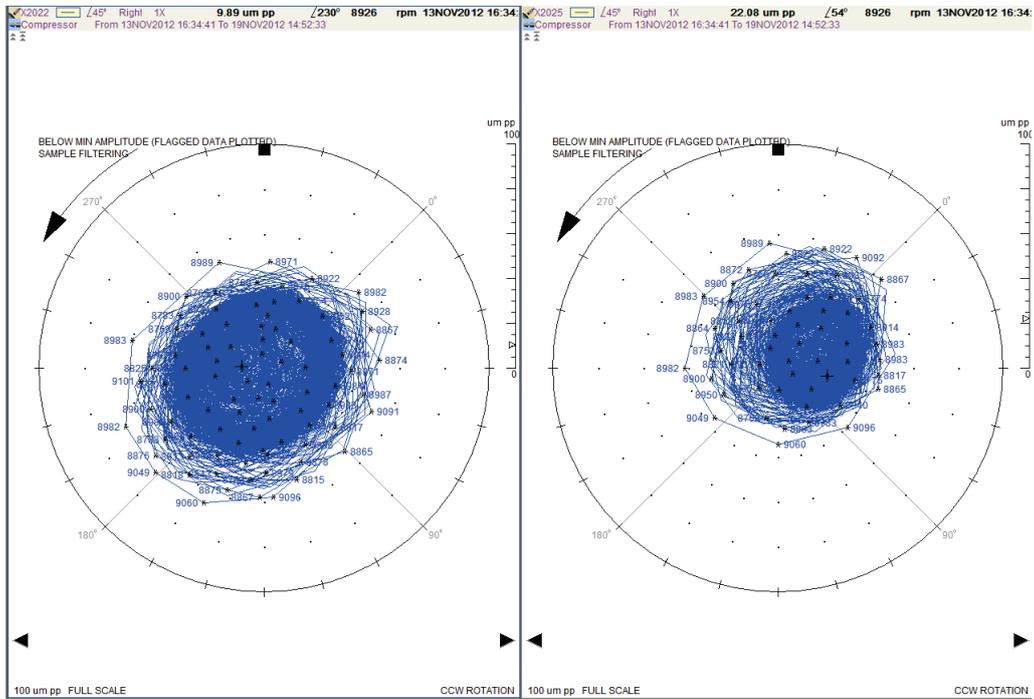
Figure 9: ADRE 1X (filtered) polar plot of vibration data recorded for a 6 day period from 13 through 19 November

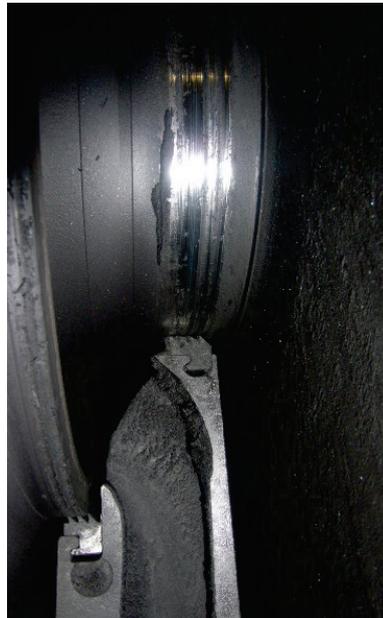
The machine was stopped and the seals were inspected. Significant deposits were found on the labyrinth seals (Figure 10). Analysis determined the composition to be ferrous sulfide, which provided important information for the plant engineering staff that was investigating the root cause of the event

Figure 10: Photos show ferrous sulphide deposits in labyrinth seals.

The deposits were so significant that the customer decided to replace the shaft rather than just cleaning it. With the spare shaft installed the clearances on the labyrinth seals were increased to accommodate the possibility of additional deposits. The compressor was restarted and operated normally with no signs of elevated vibration
