# **Steam Turbine Rotor Crack**

#### Abstract

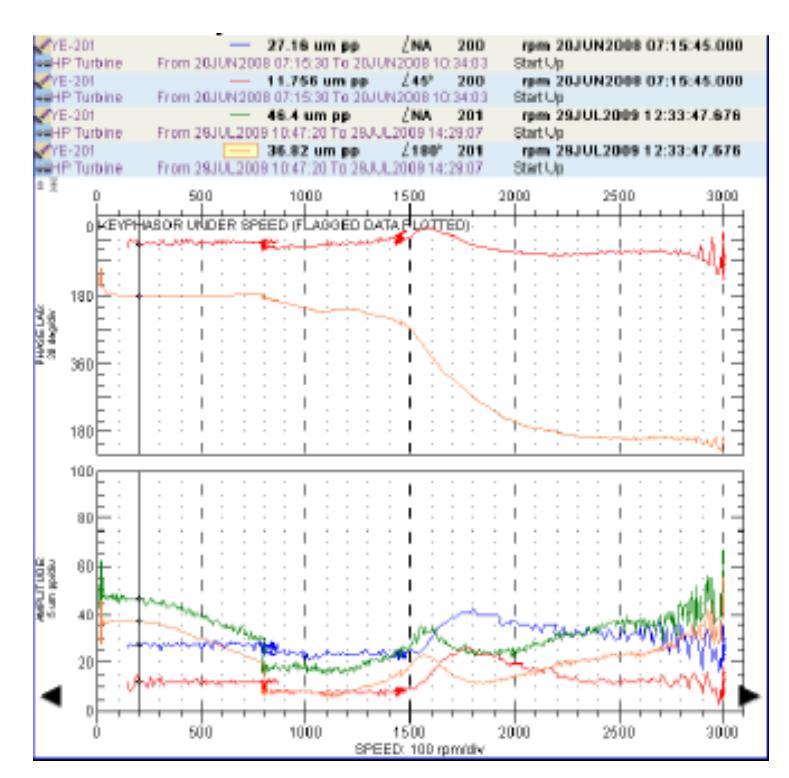
Figure 2: 1X Bode plot for the startup of June 2008 (Blue/Red) and July 2009(Green/Orange)

Fig 2 shows the startup of June 2008 and July 2009. Slow roll vectors from 2009 startup are significantly (3 times) higher than in 2008, despite 20 hours of rotor turning gear rotation. Increased 1X slow roll vectors indicates increased rotor bow, with the assumption that rotor runout was not changedFor the compared startups the 1<sup>st</sup> balance resonance frequency changed from approximately 1750-1800 rpm to 1550-1620rm. A Lower balance resonance speed indicates a decrease in rotor spring stiffness. The spring stiffness decrease and the increase of the rotor bow demonstrated by changes in slow roll vectors are expected symptoms in case of rotor crack. In general, the symptoms of the propagating transverse crack can increase rotor stiffness asymmetry, which is producing the 2X frequency component, if the rotor is subjected to steady unidirectional radial load. The 2X component can be greatly amplified, as the rotor operates at half of any balance resonance speed, because of exciting the resonance mode by 2X vibration. Fig 4 shows that the

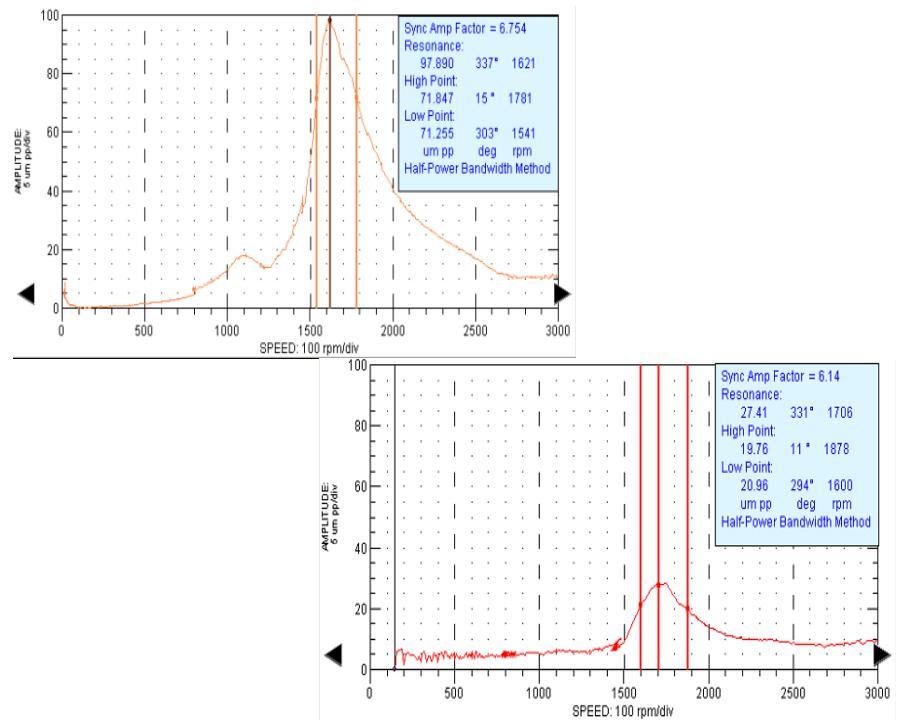
Figure 3: Synchronous amplification factor for June 2008 (Bottom) and July 2009 (Top)

When comparing data from 2008 and 2009 the 1X compensated Bode plots on Fig 3 show only slightly higher calculated Synchronous Amplification Factors using Half-Power Bandwidth Method. The SAF change is from 6.8 to 7.3 measured in the bearing 1 and from 6.1 to 6.7 measured in the bearing 2. Higher Synchronous Amplification Factors possibly indicates decreased rotor system effective damping. Decrease in rotor spring stiffness demonstrated by shifted balance resonances and decrease in effective damping demonstrated by higher SAF are symptoms of pending crack

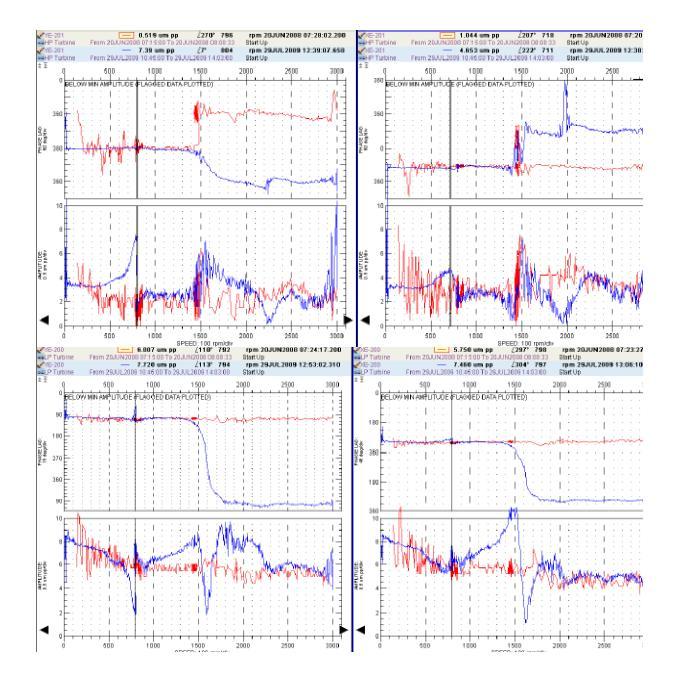
Fig 4 – 2X Bode plot from June 2008(Red) and July 2009(Blue).

above mentioned symptoms **are not visible in our case**. It is noteworthy that lack of 2X vibration does not exclude the possibility of a rotor crack. Significant 2X vibration can be absent due to either the shape of the crack, which may not cause significant asymmetrical stiffness (e.g., a circumferential crack), or due to insufficient radial preload. Fig 5 shows the difference between startup and shutdown in July 2009. At beginning of Start Up (200-800rpm), a significant change of amplitude without phase change was noticed. At constant speed (800rpm) a significant change of amplitude without phase change is noticed. Further there is visible significant difference in the slow roll vectors amplitudes comparing the same day startup and shutdown on July 29, 2009. The amplitude rise from 36umpp to 73umpp represents double increase. The phase of the slow roll vectors is the same. The phase during the shutdown 2 from 3000 rpm is not changing, neither through the 1<sup>st</sup> balance resonance region of the steam turbine bearing1. The rotor 1<sup>st</sup> balance resonance was shifted lower from startup 1551-1621rpm to 1063-1421rpm at shutdown.

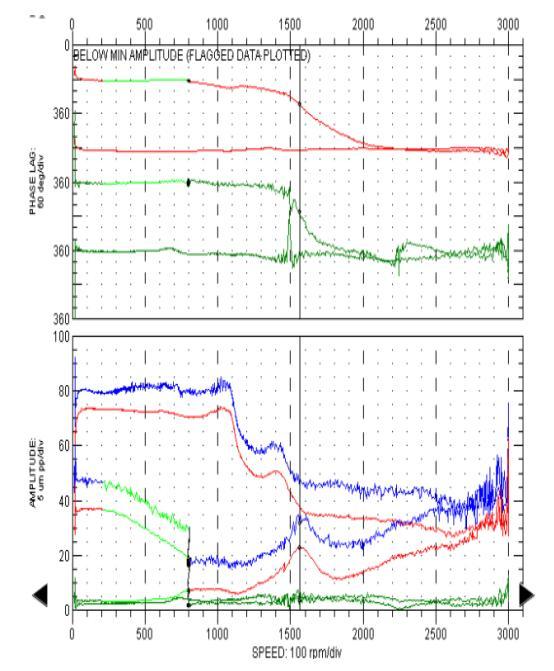
Fig 5 – 1X Bode plot for startup and shutdown in July 2009. Blue: direct, Red: 1X uncompensated, Dark green:2X, Light green: beginning of SU, Black: constant speed.

A lower balance resonance speed indicates decrease in rotor/support stiffness, which can be caused by many factors; however the presence of crack, by reduction of the rotor stiffness can cause this effect. This significant difference in rotor starts up and shut down behavior, indicates serious thermal sensitivity of the rotor

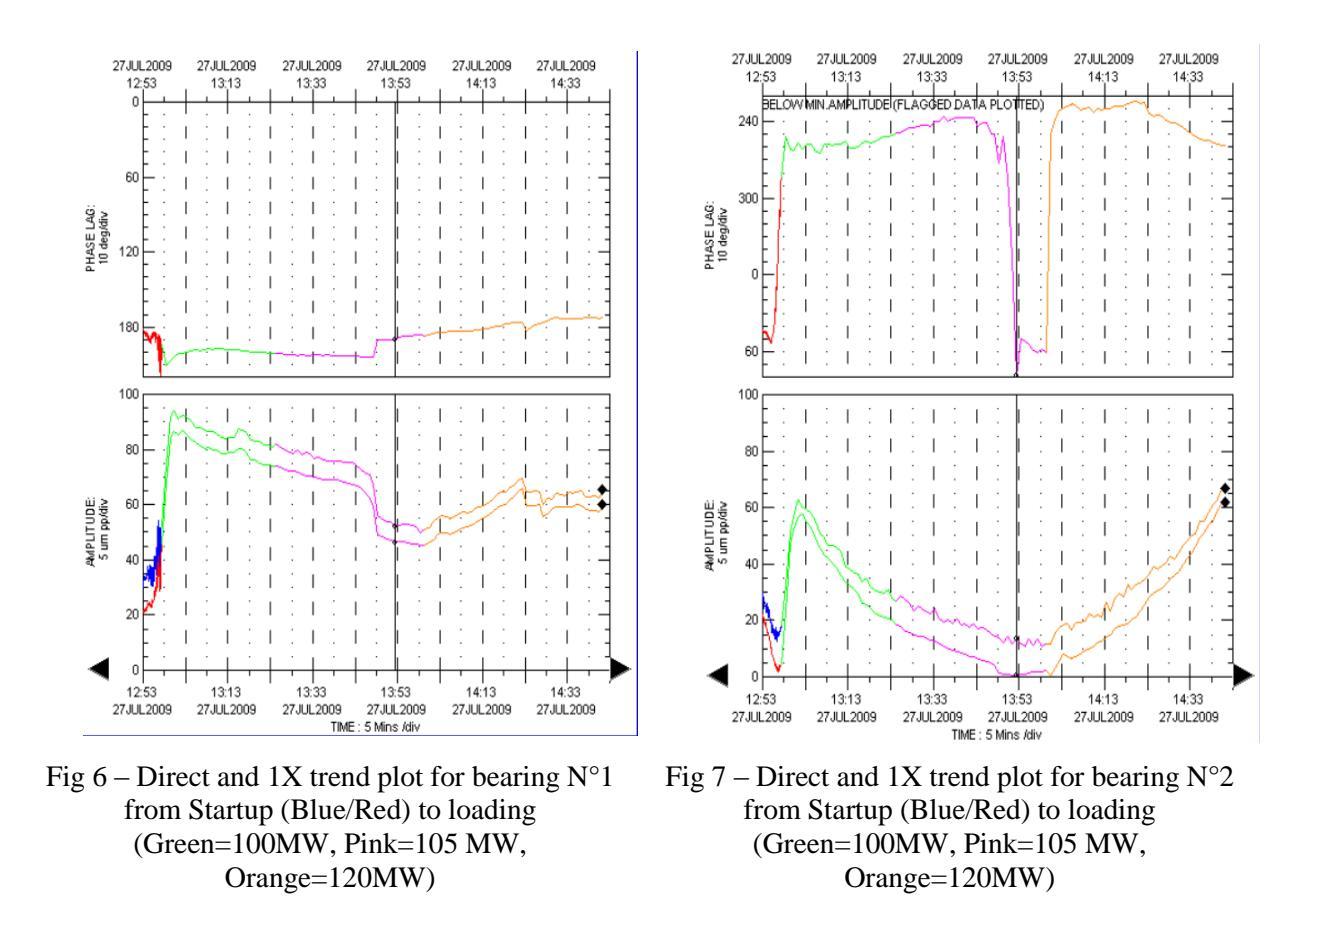
Fig 6 and Fig 7 show the trend plots of direct and 1X for steam turbine bearings during startup and loading, recorded on July 27, 2009. The amplitudes of shaft relative vibration on bearing 1 and 2, are reaching the minimum approximately in 1 hour after the synchronization. The shaft relative vibration phase is changing 180 degrees in this region (pink) at constant load and is changing again 180 degrees in the second region (orange) as the load is increased. In addition, the shaft relative vibration phase is changing 180 degrees in the speed region 2300 rpm-3000 rpm (Blue-Direct, Red-1X), where no balance resonance is expected

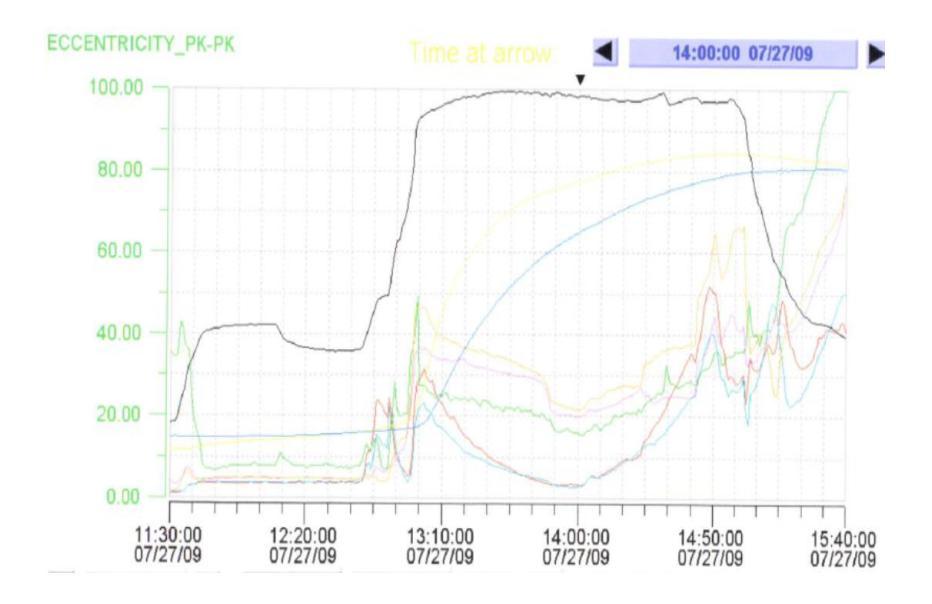
Figure 8: DCS trend showing eccentricity, shaft relative vibrations and casing temperatures

The DCS process trends (Fig 8) are showing the correlation between the eccentricities, steam turbine shaft relative vibrations and casing temperatures. When the steam turbine casing temperature reached the maximum (about 387°C), the vibrations and eccentricity measurement dropped to minimum and then started to increase. The machine was manually tripped after 2 hours at 120MW due to turbine bearings and clutch vibration growth over the alarm limits. After machine trip, vibrations, mainly on bearing 1 and eccentricity continued to increase. The eccentricity pk-pk reading increased to 200umpp at 14rpm then started to decrease

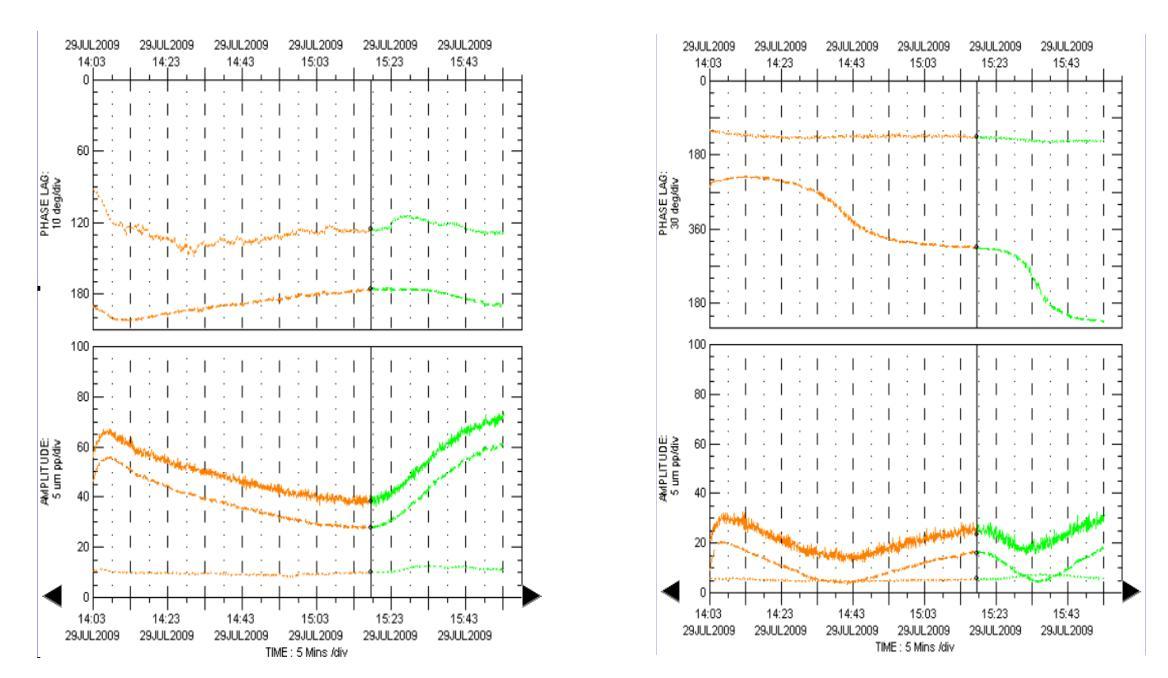
Fig 9 – Direct and 1X trend plot for bearing N°1.

Fig 9 and Fig 10 show visible amplitude and phase change during steady state at constant load. The amplitude of shaft relative vibration on bearing 1, is reaching the minimum in 1 hour after synchronization. The phase is not changing significantly. The amplitude of shaft relative vibration on bearing 2 is oscillating and is reaching maximum at this moment. The shaft relative vibration phase is changing 180 degrees in this region (orange) and is changing again 180 degrees in the second region (green).

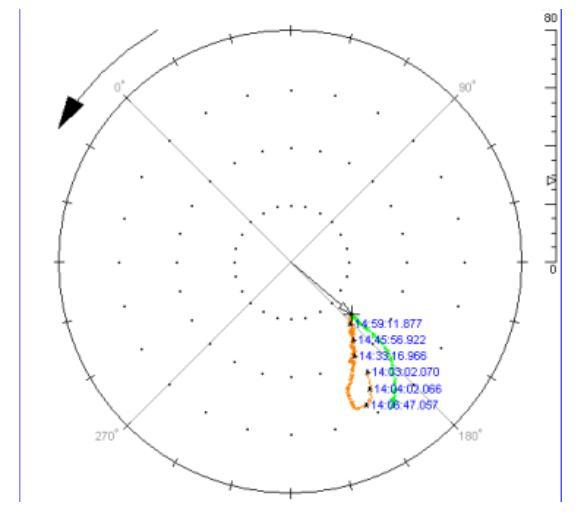
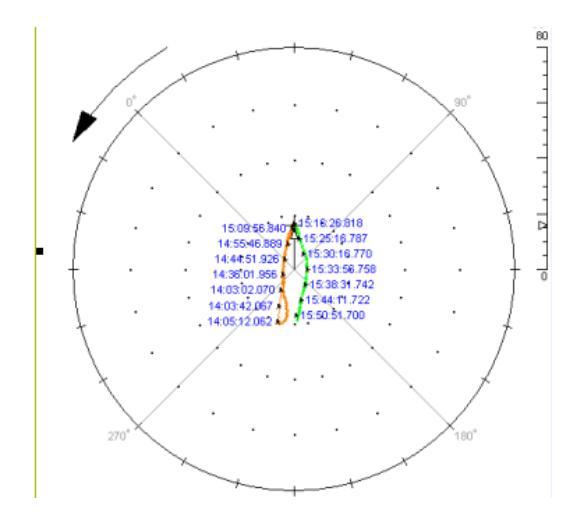
Fig 11 and Fig 12 show abnormal unidirectional rotor response change on temperature change which is another symptom supporting the possibility of presence turbine rotor crack. The change of the shaft relative vibration and eccentricity (Pk-Pk) measurement, together with phase step changes (in 1-2min), always in the same direction, suggest sudden changes in the rotor bow possibly caused by closing and opening shaft crack

Polar plots (Fig 11 and Fig 12) for bearings 1 and 2 show the unidirectional change of the shaft relative vibration during the rotor heating (orange). As the rotor thermally equalize, in our case in 1 hour after the synchronization (in 3 hours from start up), the direction of the vibration suddenly change to the opposite direction (green). The possible explanation of thermal sensitivity for the axially heated rotor is that the transverse crack acts as the insulation. The heat transfer is faster on the opposite side of the crack and the rotor starts to bow in this direction, causing the crack closing until temperature equalizes. There are also some models described in the literature for radial heat transfer, concluding that for transverse crack the heating of the rotor should cause the temporary closing the crack (surface of the shaft expand more and faster than the center of the shaft) until temperature equalizes

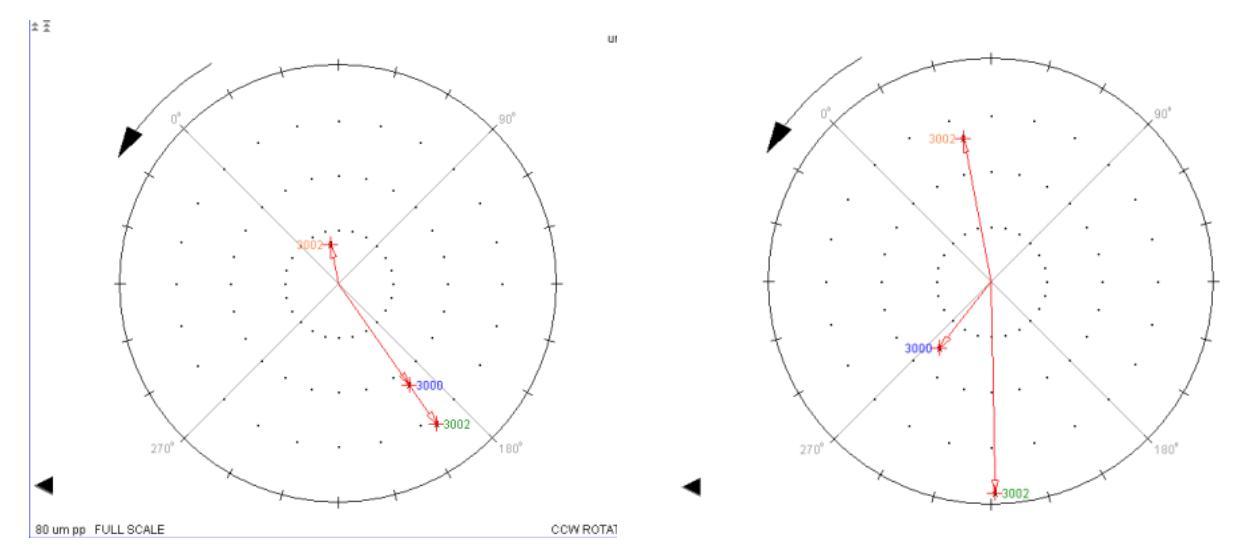
Fig 13 – 1X polar plot for bearing N°1 at 3000 rpm Fig 14 – 1X polar plot for bearing N°2at 3000 rpm

Fig 13 and Fig 14 show the original rotor response (orange) **at 3000rpm** at Full Speed No Load (FSNL) on June 20, 2008 (Orange) and the modified rotor response 1 (Blue) at FSNL at the beginning of steady state and the response 2 (green) at FSNL at the end of steady state on July29, 2009. The polar plots display the same direction for the rotor response 1 and response 2

Further, it is visible that original unbalance response vector is acting against the static bow unbalance, due to crack. The crack creates static bow, which is dominant at low speeds. This static bow unbalance is interacting with the dynamic unbalance, due to unbalance forces dominating on higher speed. The resultant 1X rotor response depends on the relative phase of the static and dynamic unbalance. The basic rule in shaft crack detection says that the cracked rotor will very likely experience the bow and the bow is likely to change over the time, with development of the crack. The change in rotor bow will change the slow roll response as well as the effective location and magnitude of the heavy spot, which will change the 1X rotor response

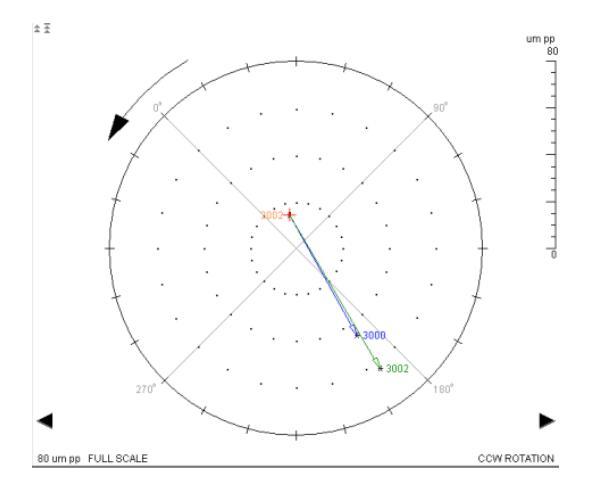
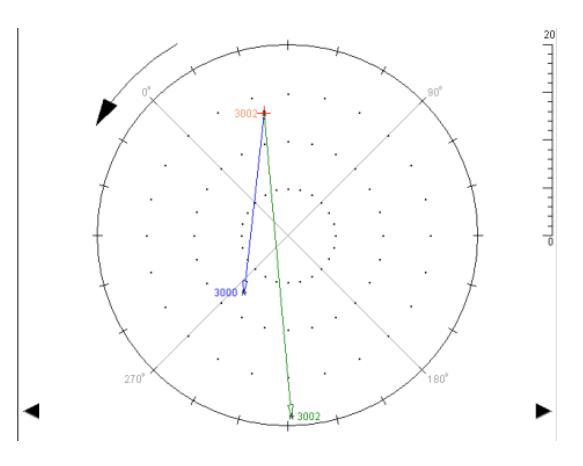
On Fig 15 and Fig 16 the effect vectors show the rotor unbalance change, caused by the rotor-modified bow, due to shaft crack. The effect vectors for bearing 1 and bearing 2 are in the same direction 190deg-220deg from YE-201 reference transducer (0° reference), what confirms the same rotor bow effect on both bearings in the same direction

The amplitude ratio of the effect vectors is similar for each bearing (effect vector 2 / effect vector 1=1,3), what confirms the similar effect of the rotor bow, due to Shaft Crack on each bearing

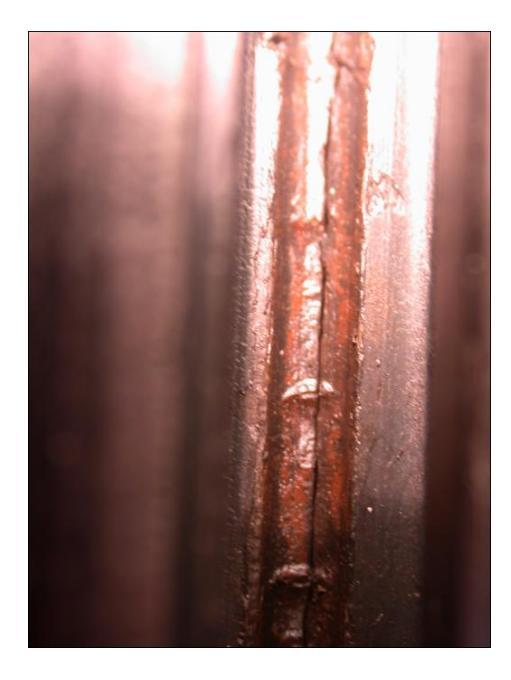
Fig 17 – Picture showing the crack found under the 1<sup>st</sup> stage bucket

The recommendation was to remove the rotor from the machine and confirm the presence of a crack using the Nondestructive Testing (NDT) techniques on the entire rotor, with special attention to regions that were not tested before (i.e., areas that including the blade grooves). Because of the costs to de-blade the rotor, these tests were not previously performed; however, the vibration test results described in this article were considered sufficient justification to incur the additional costs of de-blading and NDT re-testing. The rotor was removed from the machine, an impact hammer test was performed, and a decreased first balance resonance at 19Hz (1140rpm) was confirmed, as predicted in the report. The buckets from stages 1 through 28 were removed to investigate the bottom of the dovetail. A rotor crack was found under the first-stage bucket. The crack was symmetric and 360° circumferential, explaining the absence of an observed increase in the 2X frequency component

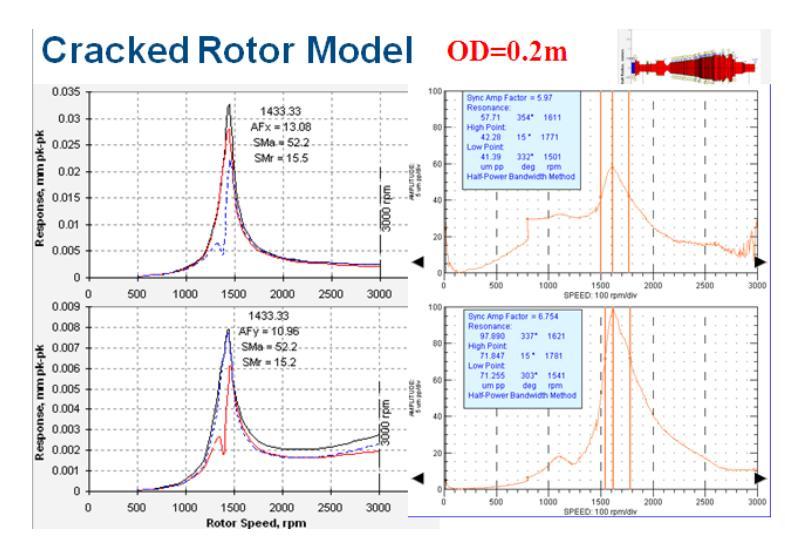
Fig 20 - Cracked Rotor model showing change in SAF and critical speed

Fig 20 shows the results from the model when using an Outer Diameter of 0.2m at the location of the crack. Critical speed and SAF were reduced significantly because of the crack. This model was created only for demonstration purpose and shouldn't be used for design

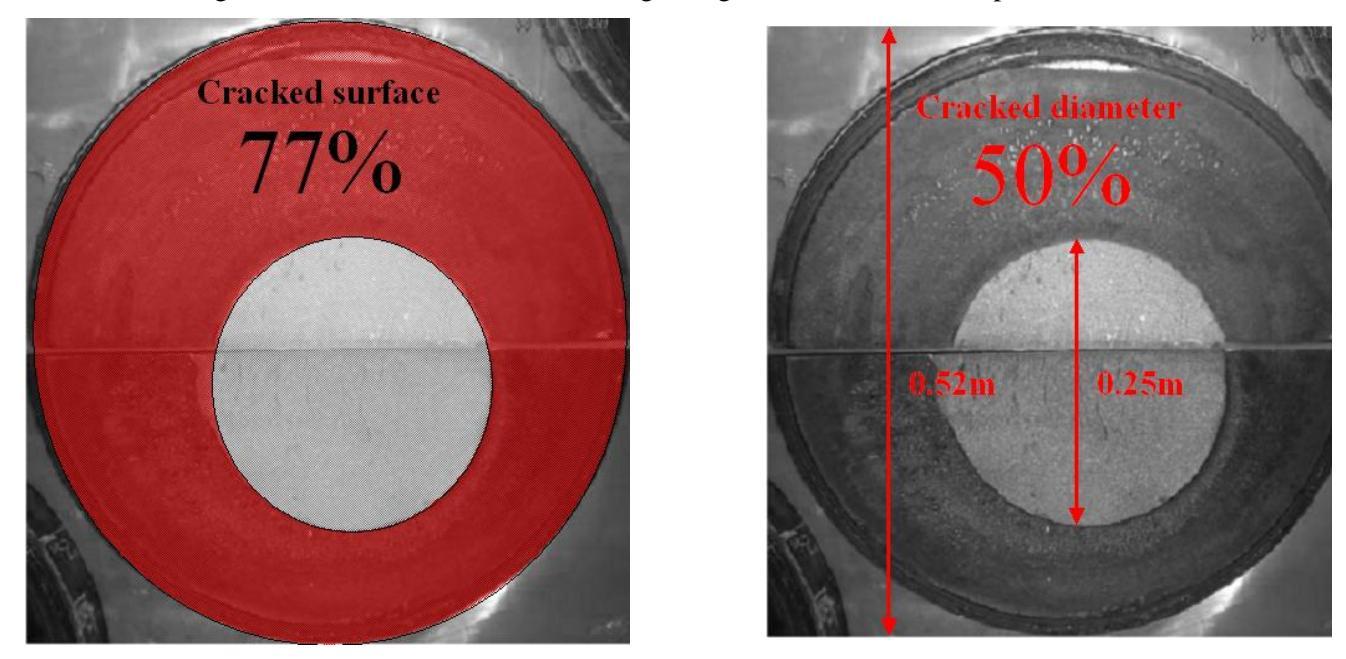
Fig 21 – Picture showing the crack surface
