Balancing of aeroderivative turbine

Abstract

GE's Machinery Diagnostic Services team was invited to investigate vibration issue on an aero derivative gas turbine installed on a power plant. Machine train consist of a generator and aero derivative turbine. The unit was under commissioning and it wasn't possible to have it at nominal speed for a long time because of high vibration on Power Turbine bearings. Vibration testing was carried out using ADRE 408 DSPi (Dynamic Signal Processing Instrument) to hook up vibration data from the existing Bently Nevada's 3500 Series vibration monitor system. Relative vibration data were collected from the Bently Nevada's Rack 3500 monitor buffered outputs. Each of the Machine Train's bearings is monitored by Bently Nevada XY proximity probe pair. Absolute velocity transducer were also installed on generator bearings and bearing #4. The shaft rotates counter clockwise, when viewed from the driver (Gas Turbine) to the driven. The first fire of this Unit was carried out the 25 May 2010. The unit had many probes in alarm. The generator DE was running in alarm and after a period of running at idle began to creep from 86um pp to 96um pp, the unit was

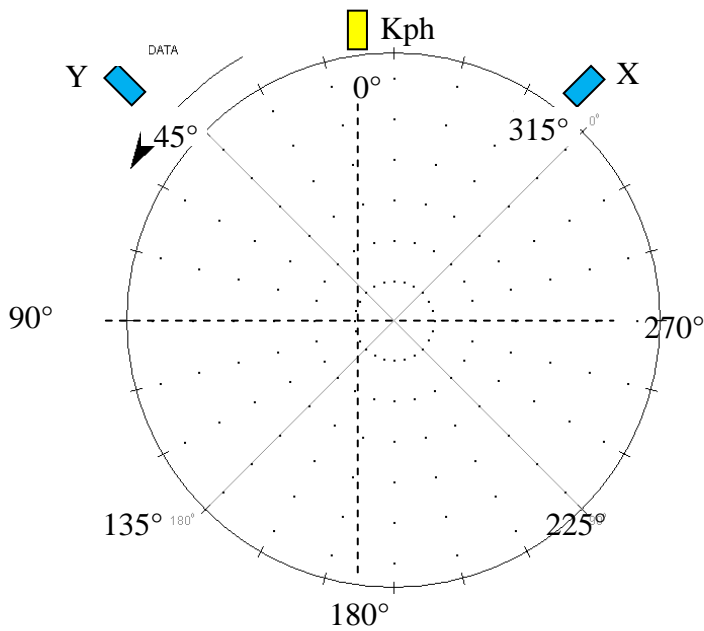
Figure 5: Balancing plane

Not enough information was available to estimate correctly a trial mass and the typical trial mass was not known for the first trial run. It was decided to add a trial weight of 100g on the coupling in order to decrease the unbalance. A small effect on the angle was observed but the amplitude of the vibration didn't change. Another run with a trial weight of 300g was done to try to have an influence on the amplitude. The vibration was not affected. Then a calculation was carried out to try a last time to balance this unit. The last run had no impact on the vibration

- Initial run (Blue) was recorded by generator OEM team.
- 1st Run (Red): A trial weight of 100g was added at 0° from the Generator Kph. This weight had an insignificant effect on the vibration amplitude but it changed the angle by 90°
- 2nd Run (Green) a trial weight of 200g was added at 20°CCW from the Generator Kph. The 100g at 0° was not removed. The weight had an insignificant effect on the vibration amplitude and on the vibration angle.
- 3rd Run (Blue) 200g and 100g weights were removed. 80g at 50° CCW was added. This modification had no effect on the unbalance.
