# Compressor rub verified by rotating phase symptoms

Nicolas Péton, Charles Grislin<sup>1</sup> and Guillaume Christin<sup>2</sup>

<sup>1</sup>GE Measurement and Control, 14 rue de la Haltinière, 44303 Nantes, France

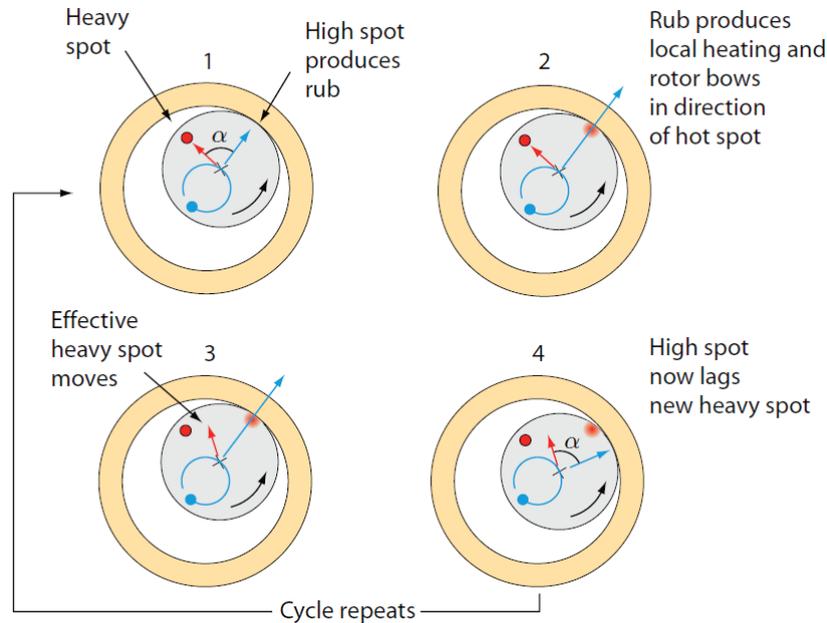
Figure 6: Phenomenon of 1X rotating phase angle produced by a light rub

By correlating the observed symptoms described above, the diagnostic engineer was able to identify the presence of light rub conditions leading to shaft bowing and resulting in 1X vibration increase with constantly changing phase angle (Reference [1])

Rubbing between rotating and stationary components can produce a hot spot and a bowed rotor. A once-per-turn rub will occur at the same location each revolution of the shaft and the friction at the contact area

will cause local heating and a hot spot. The rotor will then bow toward the hot spot, creating a new unbalance in the rotor system. The new unbalance will add vectorially with the original unbalance and if the total unbalance increases, the rub will be maintained and the 1X vibration response vector can move cyclically in a direction opposite to the direction of rotation. This effect is summarized in Figure 6 (Reference [1])
