# **Steam Turbine Rotor Crack**

#### Abstract

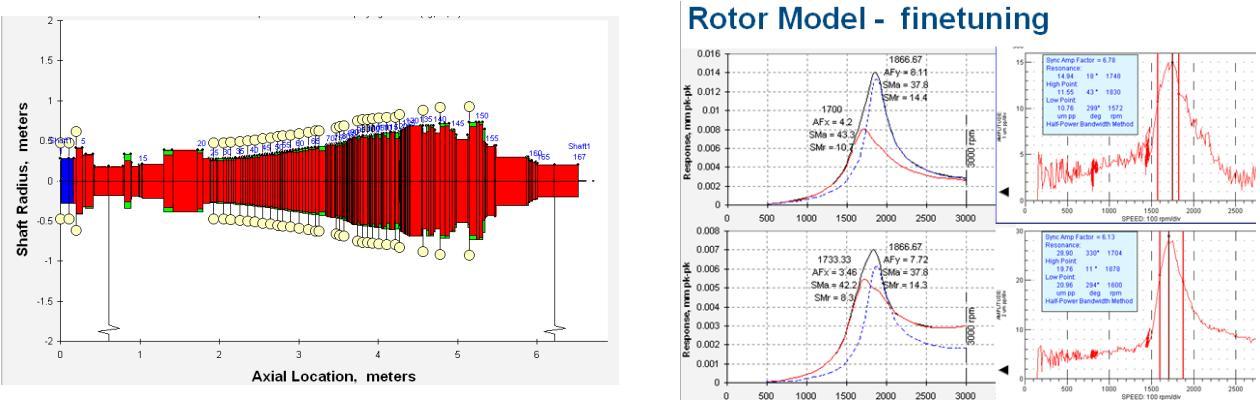
Fig 18 – Rotor model with fine tuning

vibration for assumed unbalance. This harmonic response analysis is the most common type of analysis. Fig 18 shows the model

A free-free analysis is then performed to calculate frequencies for comparison to frequencies measured in an impact hammer test. If a machine runs near or above any rotor modes with a lot of shaft flexing and little damping it could be worth making sure the shaft model is accurate as possible. Comparison with measured frequencies can be used to validate the model, or fine tune it. The free-free analysis doesn't include any information from the support.

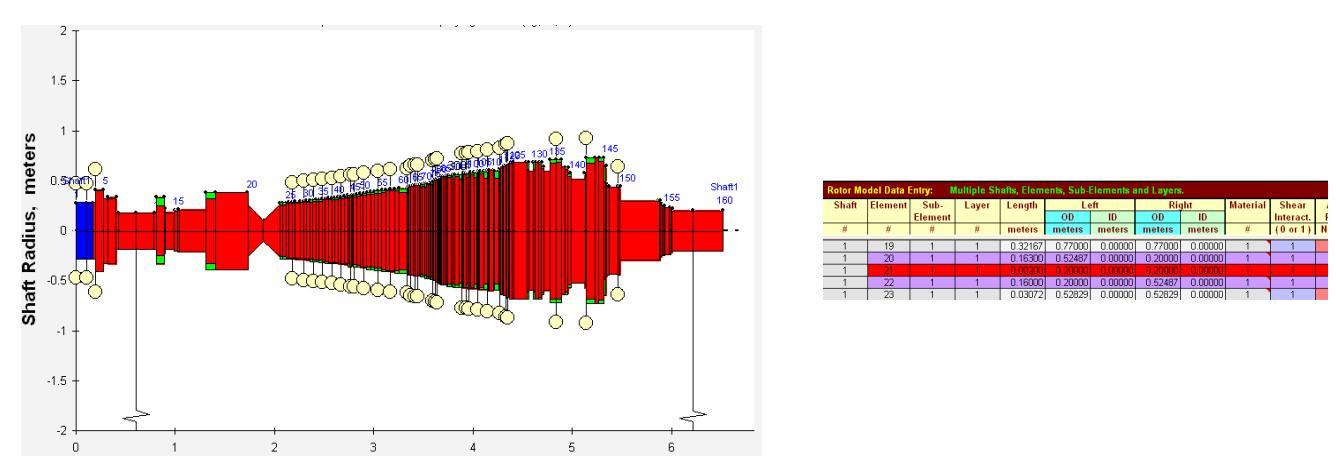
Fig 19 - Rotor model with Outer Diameter of 0.2m at the location of the crack

Once the model was tuned using different parameters for the preload and the bearing clearances the crack was simulated by a change in rotor diameter at the location of the crack. In the case of strong variation in diameter, it is suggested to take into consideration in the model the part of the material which does not participate to the stiffness by an intermediate element, as in Fig 19.

Fig 20 shows the results from the model when using an Outer Diameter of 0.2m at the location of the crack. Critical speed and SAF were reduced significantly because of the crack. This model was created only for demonstration purpose and shouldn't be used for design
